RESEARCH MEMORANDUM

EXPERIMENTAL INVESTIGATION OF ROTATING STALL AND

BLADE VIBRATION IN THE AXIAL-FLOW COMPRESSOR

NACA RM E54A08

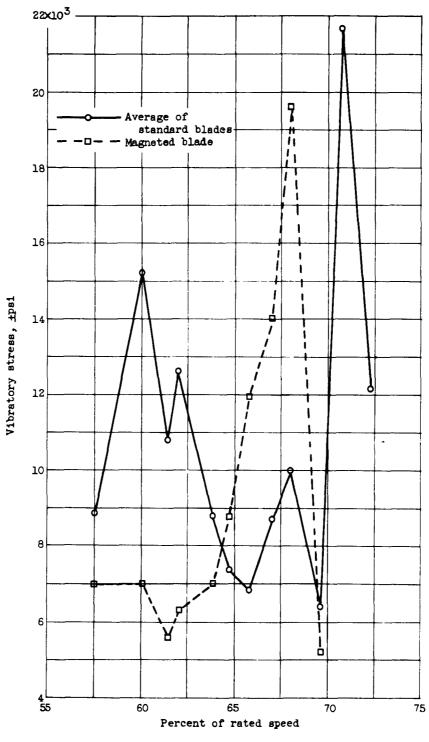
Figure 6. - Vibratory stress measured in first-stage rotor blades with configuration 3.

A plot of the vibratory stress against percent of design speed obtained with configuration 3 is shown in figure 6. It can be readily seen that two critical speeds are present over the speed range from 58 to 72 percent of design speed. Also note that the "magneted" blade reached its maximum vibratory stress at a lower speed than the standard blade.

After these two critical speeds were observed, the balance of the investigation was guided to determine their cause. Operation with configuration 4 resulted in vibratory stress of $\pm 34,800$ pounds per square inch in the high critical speed range (70 percent of design speed), and was the highest vibratory stress measured during the investigation.

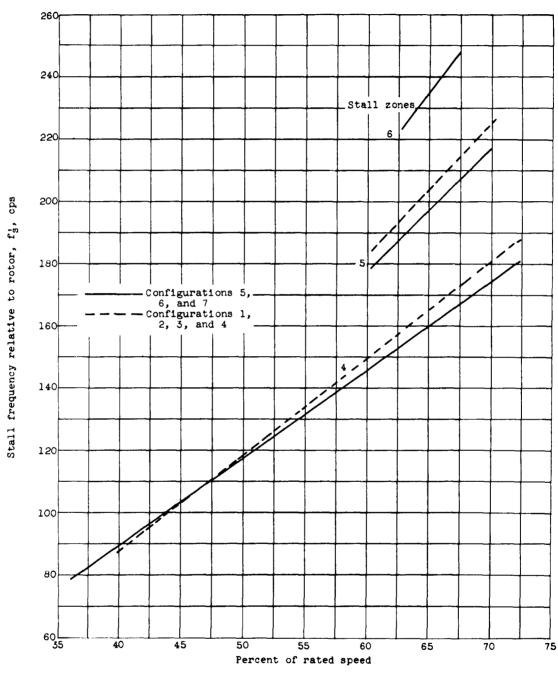
Figure 8. - Variation of stall frequency relative to rotor with percent of rated engine speed.

The stall frequency relative to the rotor f's for the seven engine configurations investigated is presented as a function of rated engine speed in figure 8. As can be seen from figure 8, the stall frequencies relative to the rotor for a given stall pattern obtained with configurations 1 through 4 are slightly greater than those obtained with configurations 5 through 7 at engine speeds above 50 percent of rated speed. As pointed out previously, a stall pattern with six zones was not found with configurations 1 through 4.

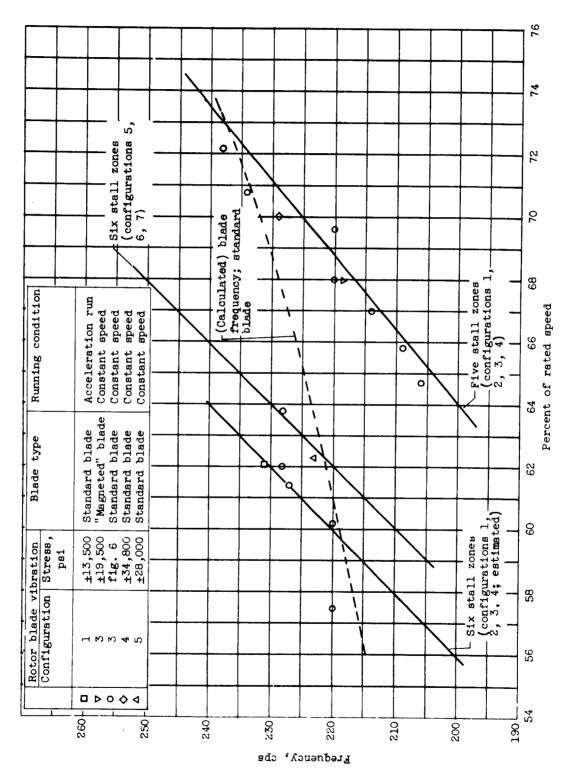
Figure 9. - Correlation of relative stall frequency with rotor-blade vibration frequency.

In order to establish whether the blade vibrations obtained were excited by rotating stall, the stall frequency relative to the rotor f's was compared with the blade vibration frequencies. The principal results of the comparison are shown in figure 9. The vibrational frequencies of the first-stage rotor blades and the stall frequency relative to the rotor are plotted against percent of rated speed. In addition, the calculated variation of the average natural frequency of the standard first-stage rotor blades with engine speed is shown. The variation of bending frequency among the first-stage rotor blades was about ±5 cycles per second. The effect of engine speed on the natural bending frequency was estimated by the method presented in reference 13.

Good correlation between the five-zone stall frequency relative to the rotor and the blade vibrational frequency is indicated at engine speeds between about 65 and 72 percent of rated engine speed. This correlation indicates that the blades were excited by rotating stall. Examination of the oscillogram records indicated the time duration of the bursts of vibration corresponded to the time a five-stall pattern was present in the compressor. As mentioned earlier, the stall patterns were changing intermittently. The magnitude of the vibration stresses of each circled point in figure 9 is shown in figure 6.
